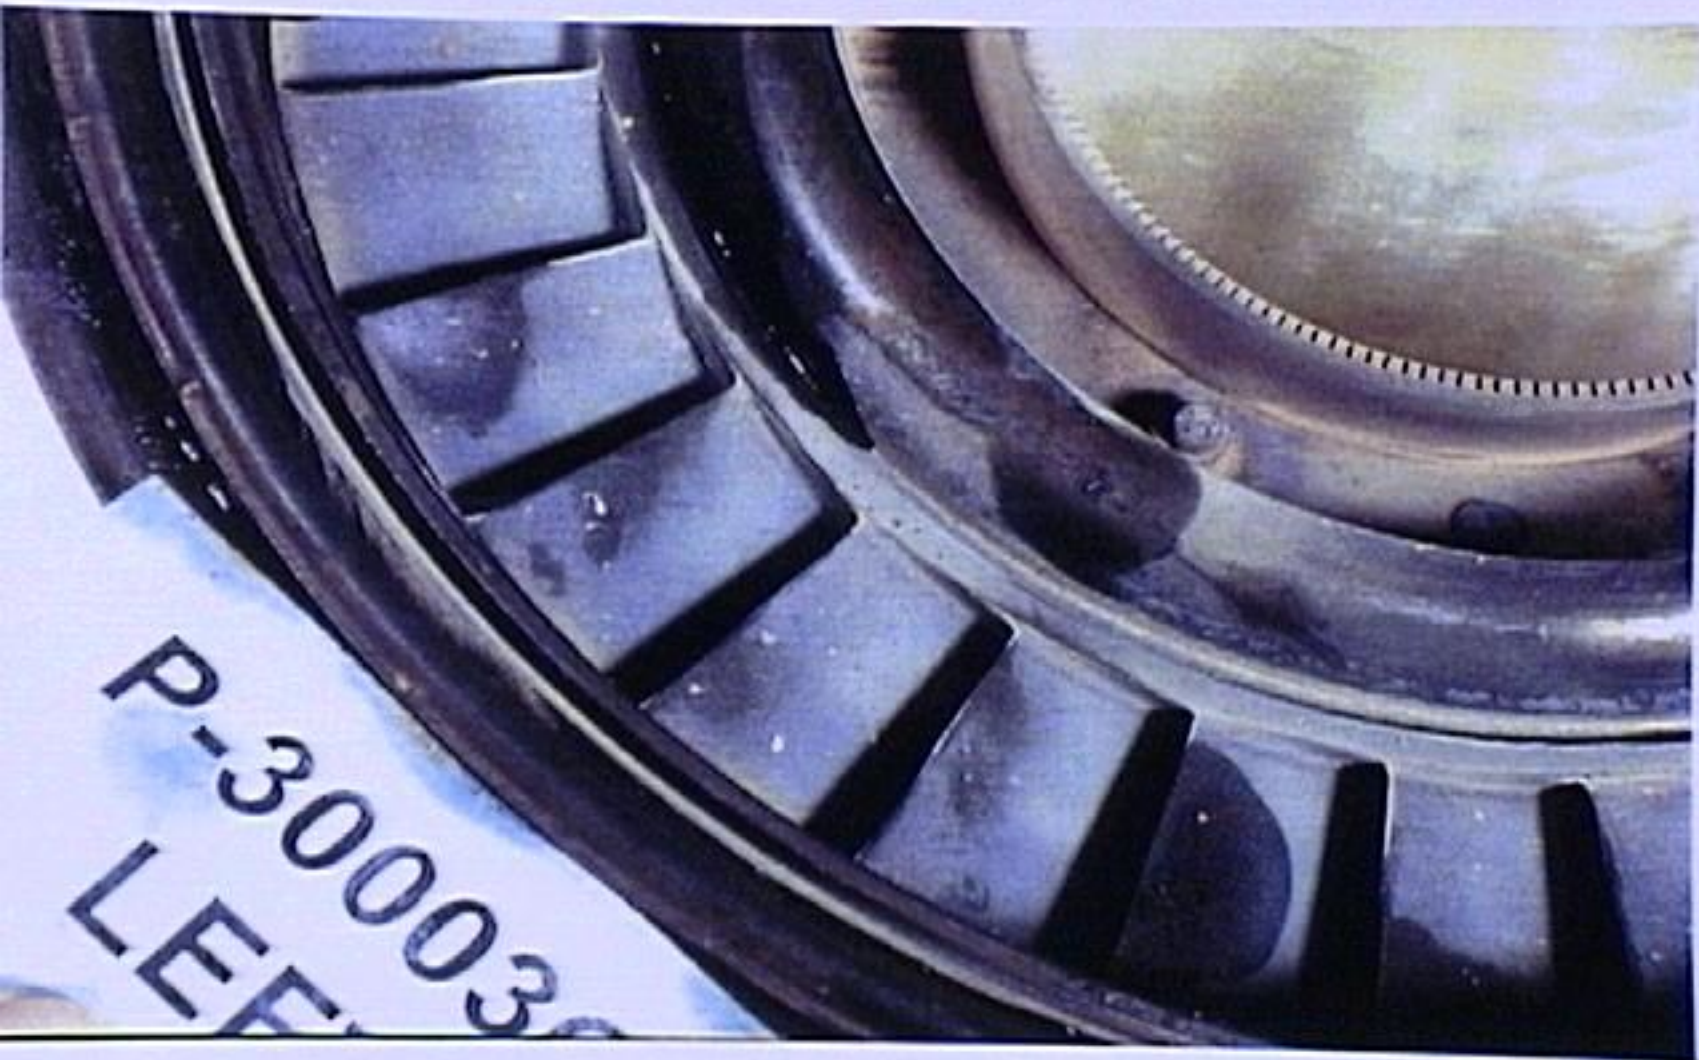
Figure 41. Metal Spray Deposits on the Second-Stage Stator Vanes
